Manhole Inspection Summary

Manhole # S39U1_009MH

Location Address: **216 Maude Ave.**

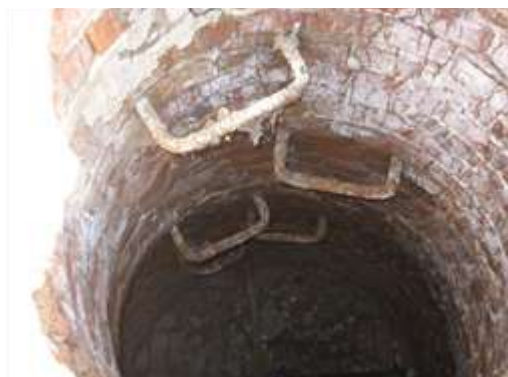
Steps Count: **5** Missing: **0** ☐ Corroded

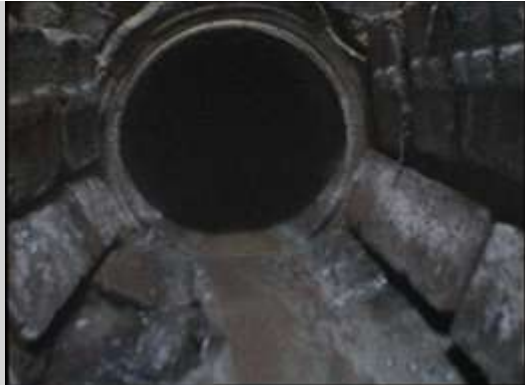
12 O'Clock Outflow

8 in. Circular Gravity Sewer
Pipe Out @ 12 O'Clock

Pipe Height: **9.6** (in.) Rod and Bar (Angled)
Pipe Material: **Unknown** ☐ Pipe Lined
Invert Depth: **10.50** (ft.) Flow Characteristics: **Slow**
Deposits: ☒ None ☐ Mud ☐ Sludge ☐ Debris ☐ Grease
Silt Depth: (in.) Deposits Extent:
Infiltration: **None** Pipe Seal Cond: **Sound**

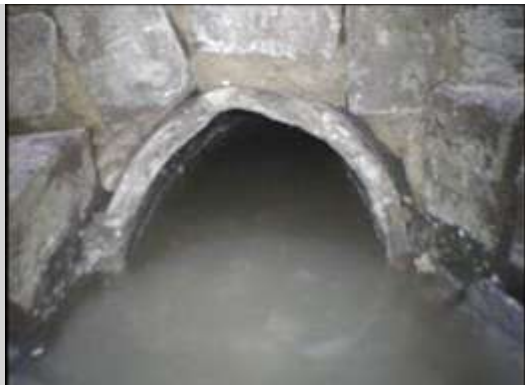
9 O'Clock Inflow

8 in. Circular Gravity Sewer
Pipe In @ 9 O'Clock

Pipe Height: **8.4** (in.) Rod and Bar (Angled)
Pipe Material: **Clay** ☐ Pipe Lined
Invert Depth: **10.50** (ft.) Flow Characteristics: **Slow**
Deposits: ☒ None ☐ Mud ☐ Sludge ☐ Debris ☐ Grease
Silt Depth: (in.) Deposits Extent:
Infiltration: **None** Pipe Seal Cond: **Sound**
